Report Number Y-1234

UNION CARBIDE NUCLEAR COMPANY  
DIVISION OF UNION CARBIDE CORPORATION

Y-12 PLANT

ACCIDENTAL RADIATION EXCURSION AT THE Y-12 PLANT  
June 16, 1958  
Final Report

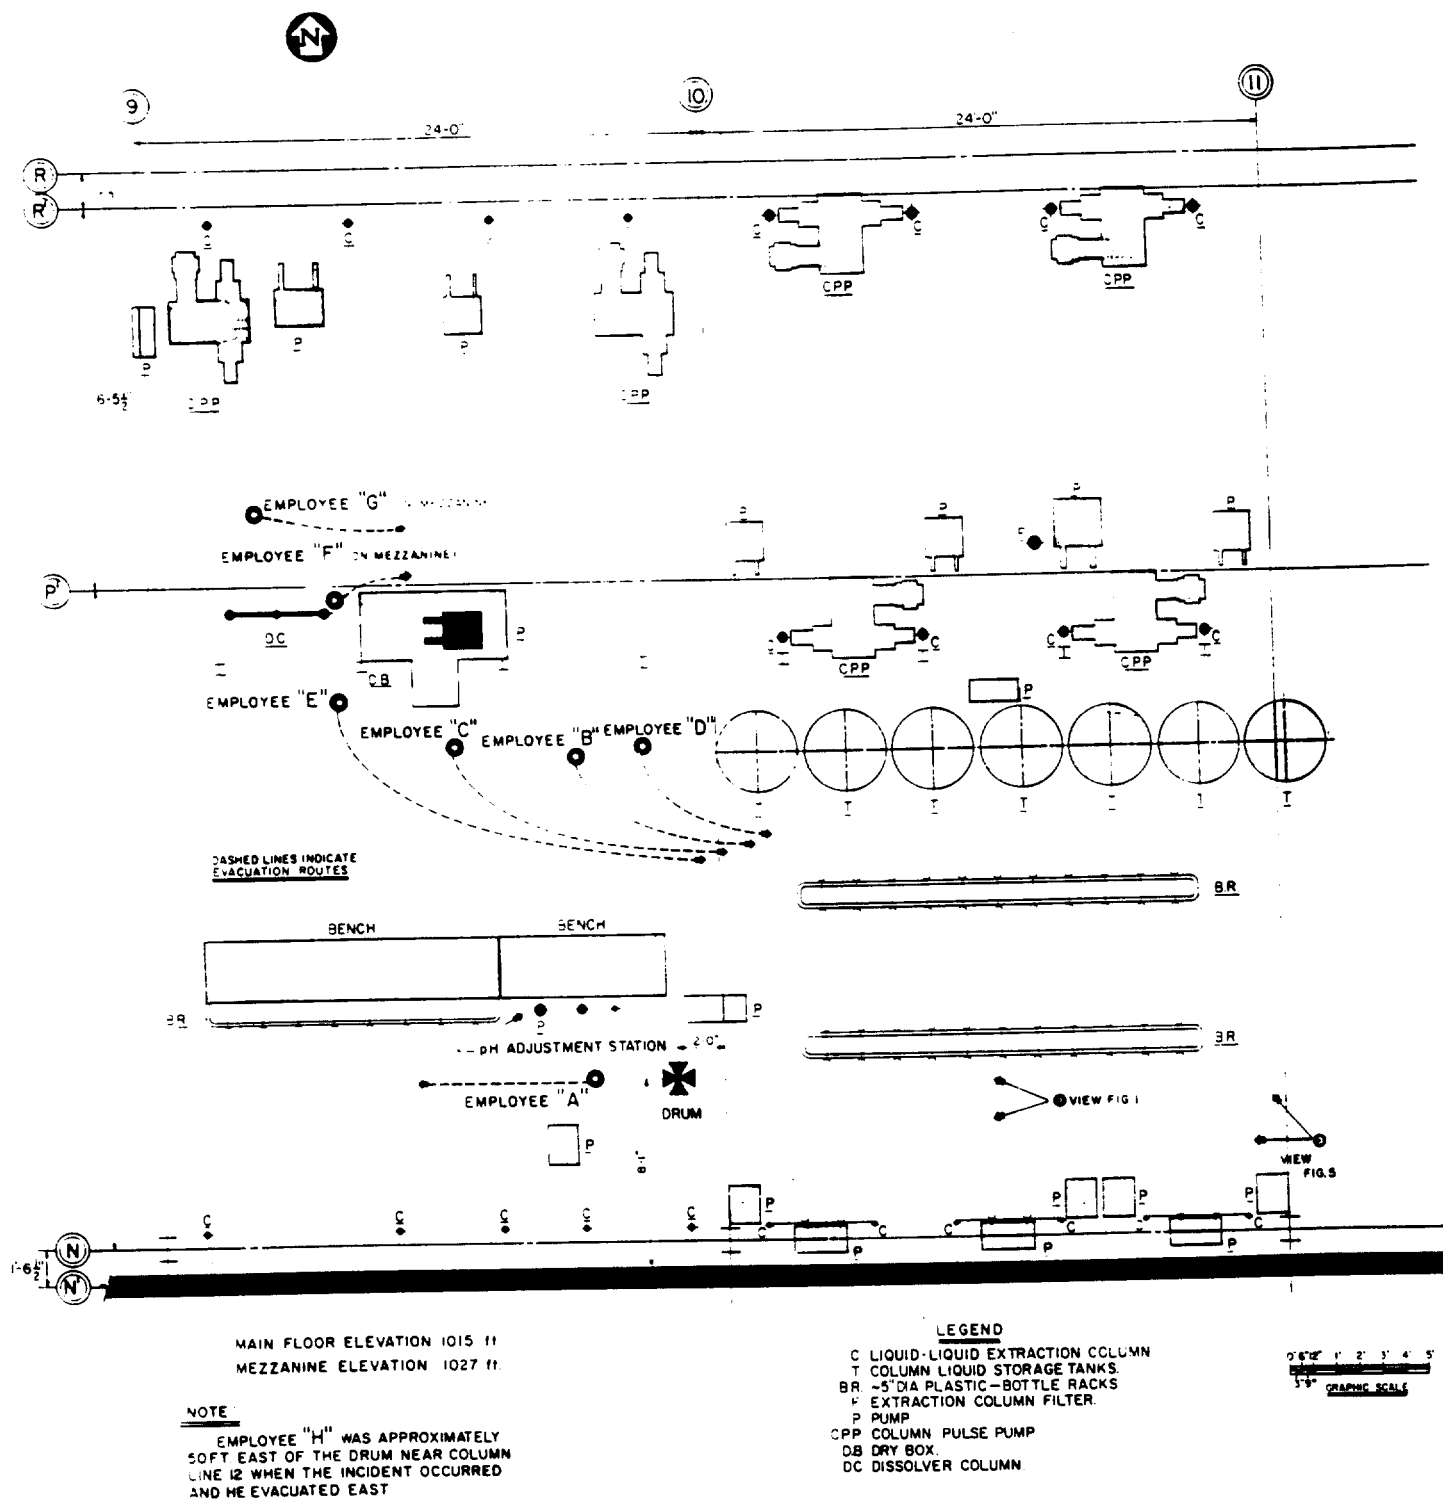
Figure 4  
EQUIPMENT LOCATION PLAN IN AREA OF NUCLEAR EXCURSION

The positions of Employees "A", "B", "C", "D", and "E" at the time of the incident are portrayed in Figures 4, 5, and M.1. With regard to Operator "A" (height 5 ft., 11 in.), it is to be noted from Figures 4 and M.1, that the 5 ft., 9 in. high by 20 ft. long stainless steel laboratory bench limited his view of the positions and movements of other employees.

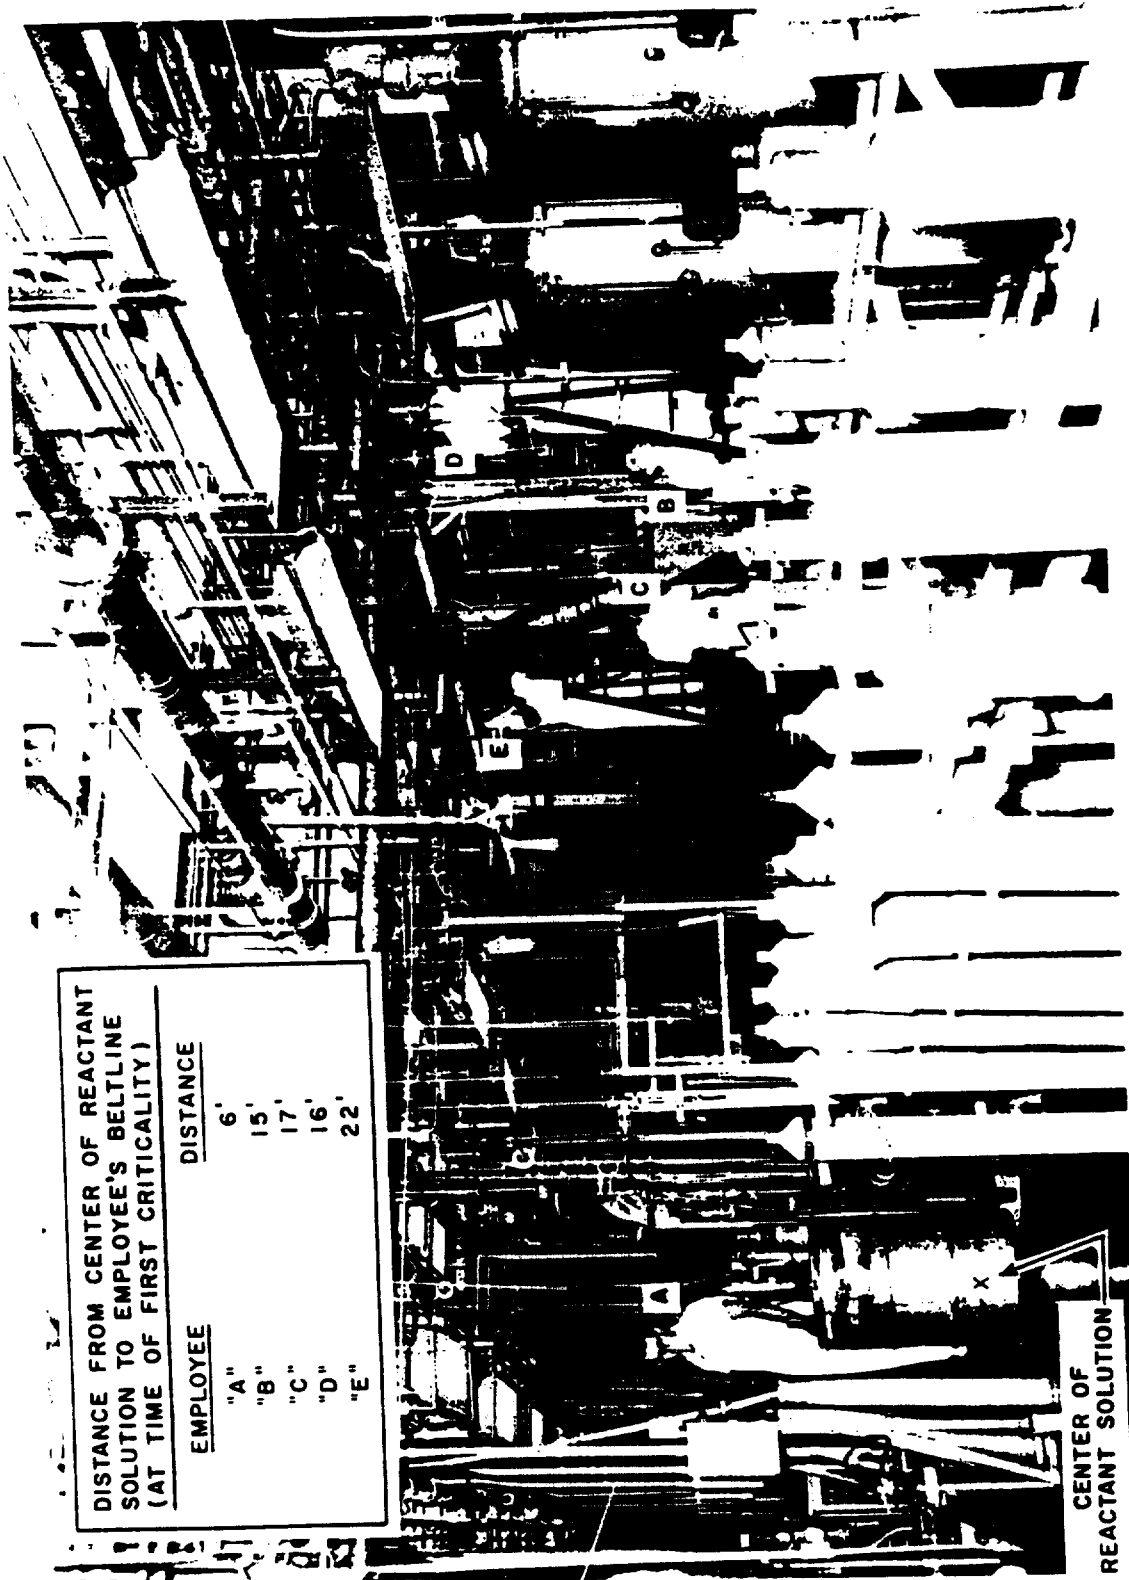
Figure 5  
 RE-ENACTMENT OF POSITIONS OF EMPLOYEES IN THE PROXIMITY OF THE DRUM  
 AT THE TIME OF THE INCIDENT  
 Looking West

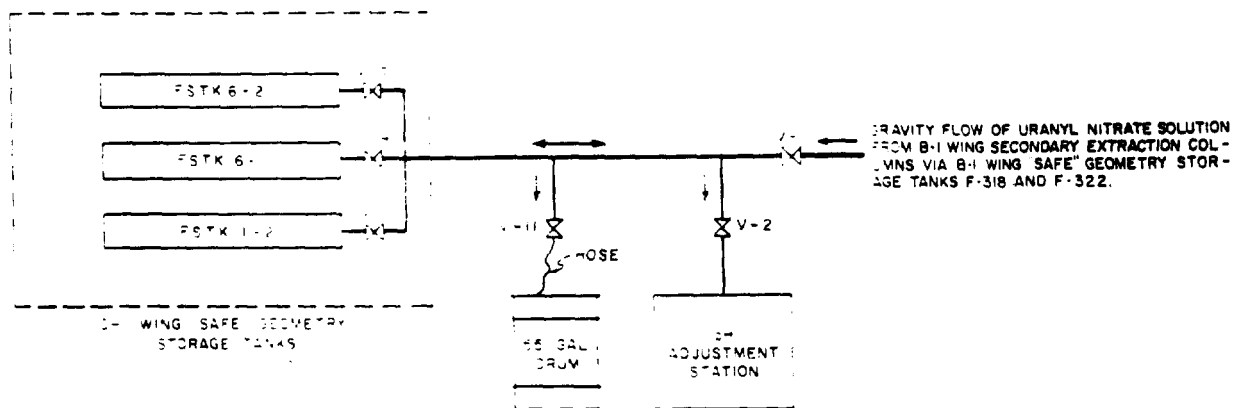
The closing of valve V-2 allowed the uranyl nitrate solution, which had been leaking into the pH adjustment station standpipe, to back up into the C-1 Wing "safe" geometry storage tanks (see Figure 6).

Figure 6  
SIMPLIFIED SCHEMATIC OF PIPING INVOLVED IN THE ACCIDENT

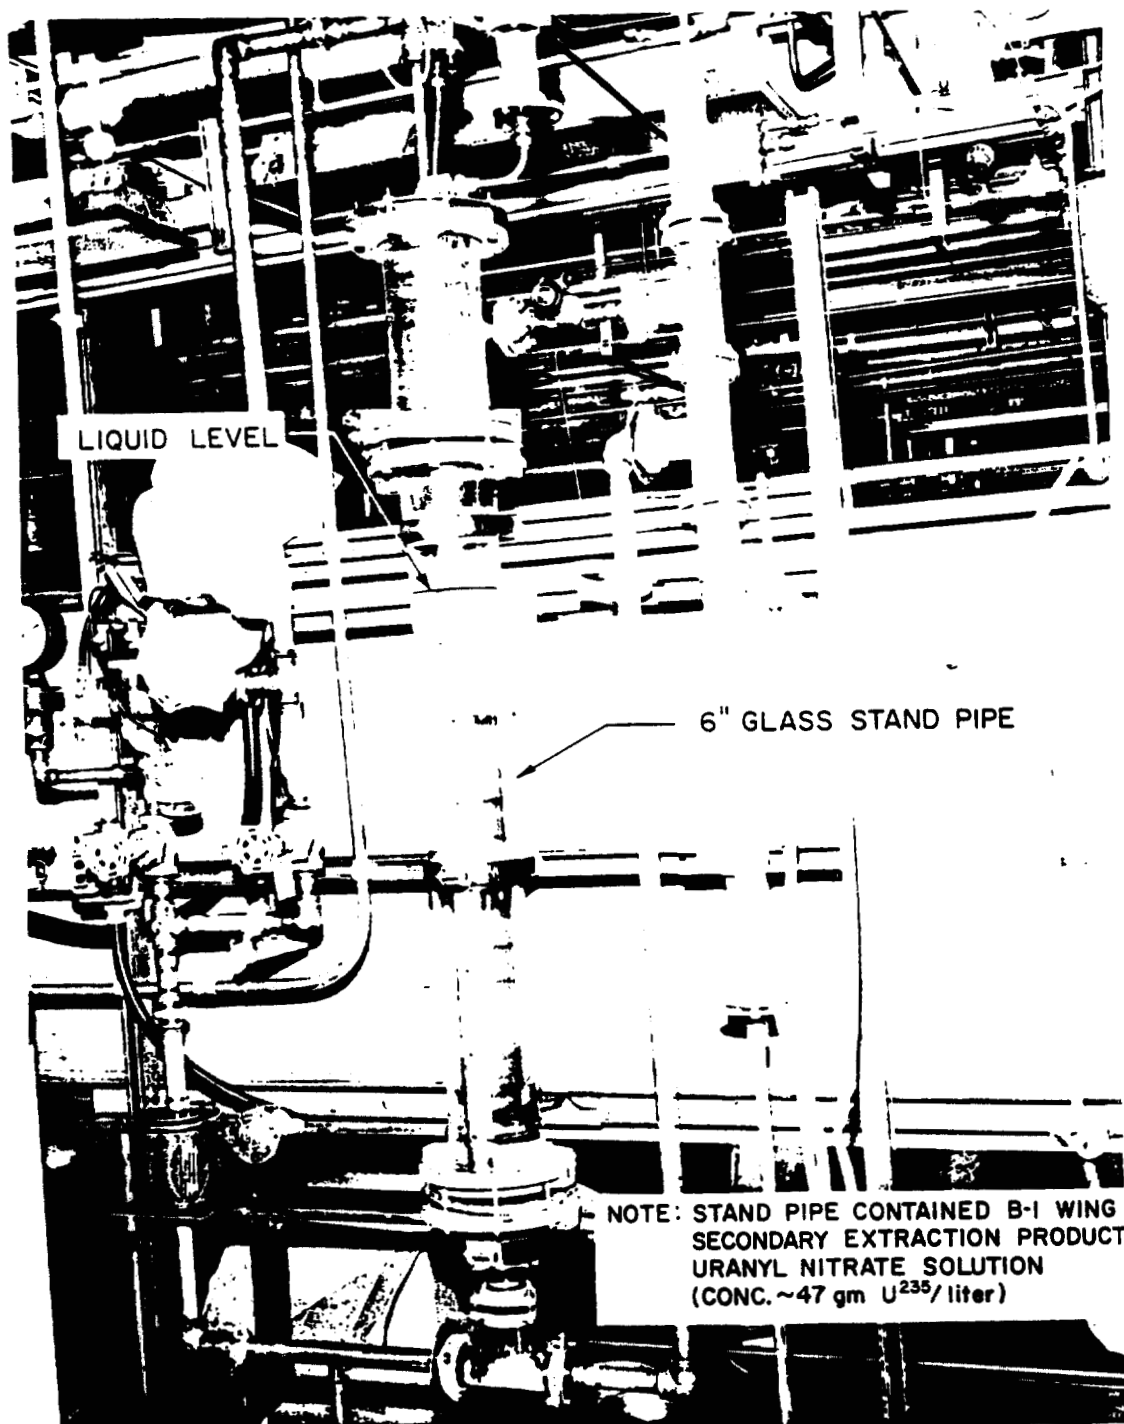
Figure 7  
pH ADJUSTMENT STATION C-1 WING  
(Photograph Taken Approximately 24 Hours After the Critical Incident)

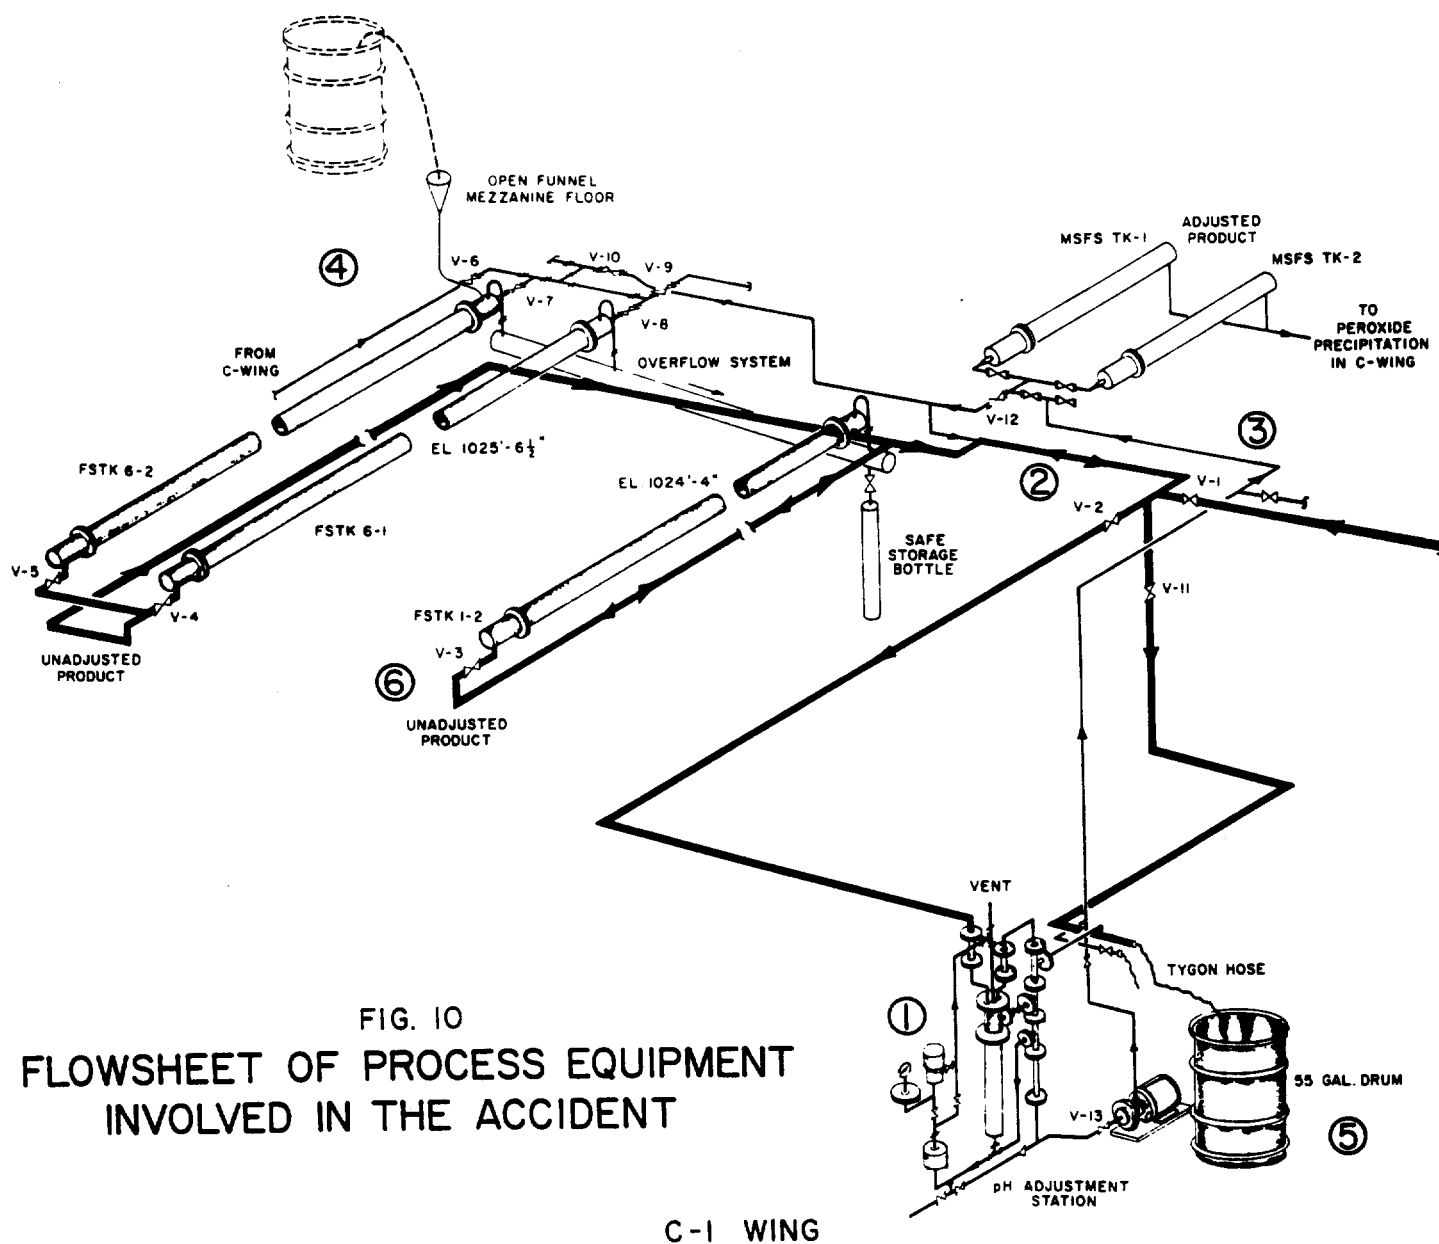
- ① YELLOW URANYL NITRATE SOLUTION NOTICED AT pH STATION ABOUT 5:00 A.M.
- ② V-2 CLOSED AT ABOUT 5:00 A.M.
- ③ V-1 CHECKED CLOSED ABOUT 1:30 P.M.
- ④ SAFE TANKS FSTK 6-1 AND 6-2 WERE LEAK TESTED BY FILLING FSTK 6-2 WITH WATER THROUGH FUNNEL ON MEZZANINE.
- ⑤ CRITICAL EXCURSION OCCURRED IN 55 GALLON DRUM AT 2:05 P.M.
- ⑥ V-3 WAS FOUND OPEN AFTER INCIDENT.
- ⑦ V-4, V-5, V-7, V-8 AND V-11 WERE FOUND OPEN AFTER INCIDENT.
- ⑧ V-9, V-10, V-12 AND V-13 WERE FOUND CLOSED AFTER INCIDENT.

FIG. 10  
FLOWSHEET OF PROCESS EQUIPMENT  
INVOLVED IN THE ACCIDENT

transfer line. The primary control valve (V-1, in Figure 10) was located in C-1 Wing and was controlled by the C-1 Wing process foremen.

Upon receiving an affirmative answer, this supervisor observed that solution was leaking through valve V-2. (See Figure 10.) Foreman "Y" then closed valve V-2 which leads to the pH adjustment station. Valve V-1, which controls the flow of concentrated uranyl nitrate from B-1 Wing, was not checked.

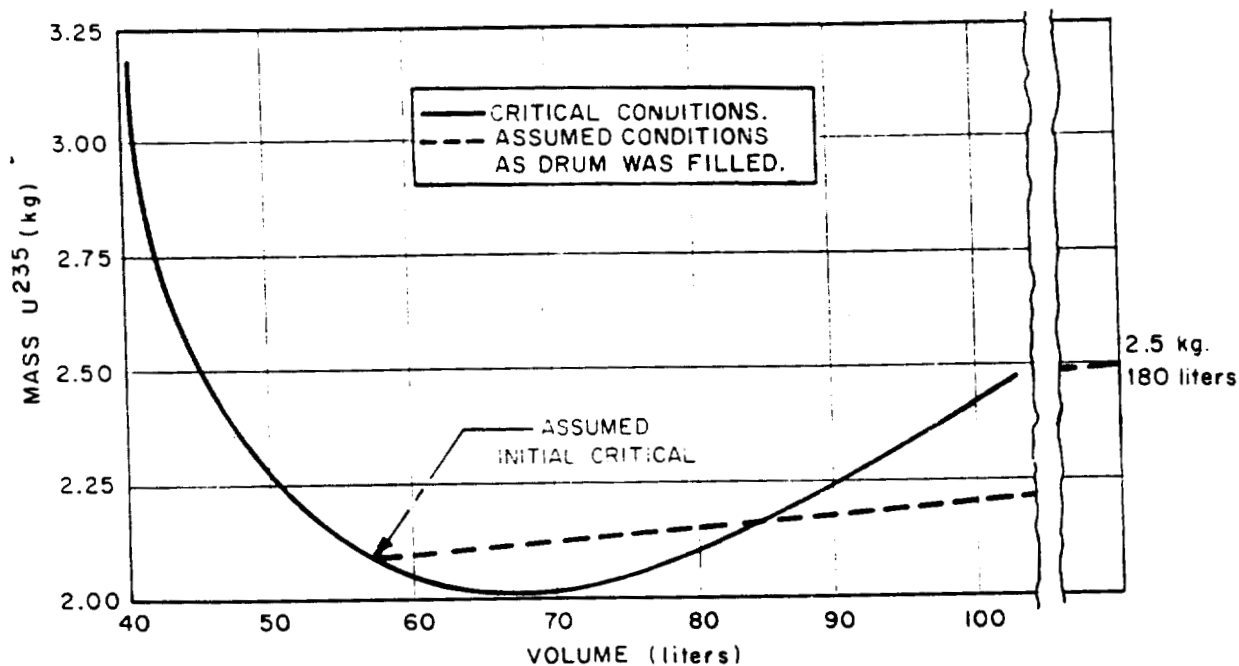
Chemical analysis has shown 50 g  $U^{235}$ /liter to be the most concentrated solution available for transfer to the drum and 2.5 kg  $U^{235}$  as the mass transferred. A plot, Figure 11, of a short extrapolation of measured critical dimensions of  $U^{235}O_2F_2$  solutions ( $\sim 90\%$   $U^{235}$ ) gives critical masses as a function of critical volumes in a 21.75 in. diameter unreflected steel cylinder. It is seen that the above quantities set 7.6 and 17.2 inches as the lower and upper limits on the critical height. Since both the sequence of valving operations postulated and data from the hydraulic reconstruction experiments stipulate some dilution of the original solution as it flowed into the drum, a volume of 56.2 liters containing 2.10 kg  $U^{235}$  standing at a height of 23.45 cm (9.23 inches) is selected as the initial delayed critical configuration. This selection is justified by three factors - the reactor analysis, based on the initial conditions, yields time intervals consistent with what is believed to be the observed duration of the excursion; the assumed critical height agrees with both the liquid level estimated in the drum by the individual standing nearby at the time of the first indication of a reaction and with the distribution of induced activity in the walls of the drum described below. If it is assumed that the concentration of the solution subsequently added to the drum is uniform and that the volume in the drum reached 180 liters when the entire

Figure 11  
MASS-VOLUME RELATIONS IN 55 GALLON DRUM DURING RADIATION EXCURSION

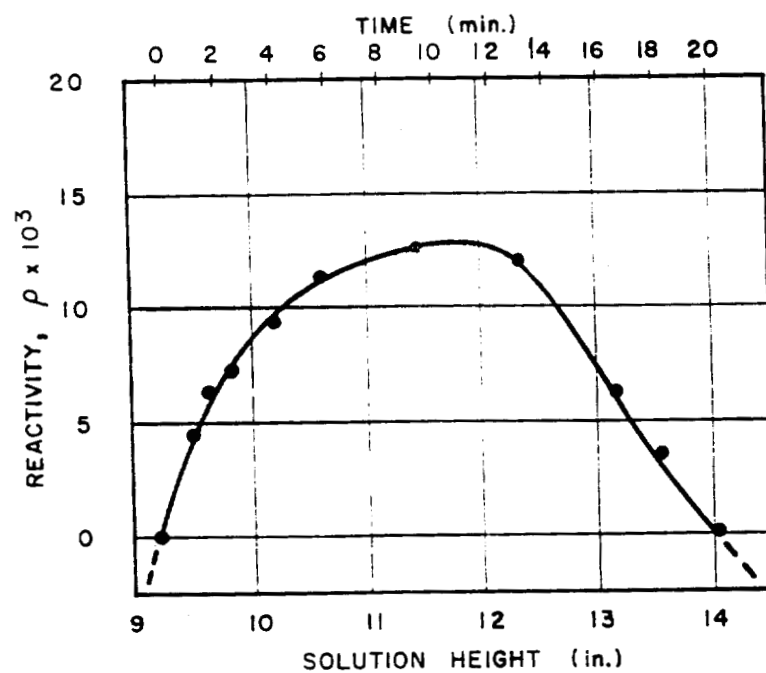
Figure 12  
CALCULATED REACTIVITY IN DRUM DURING RADIATION EXCURSION

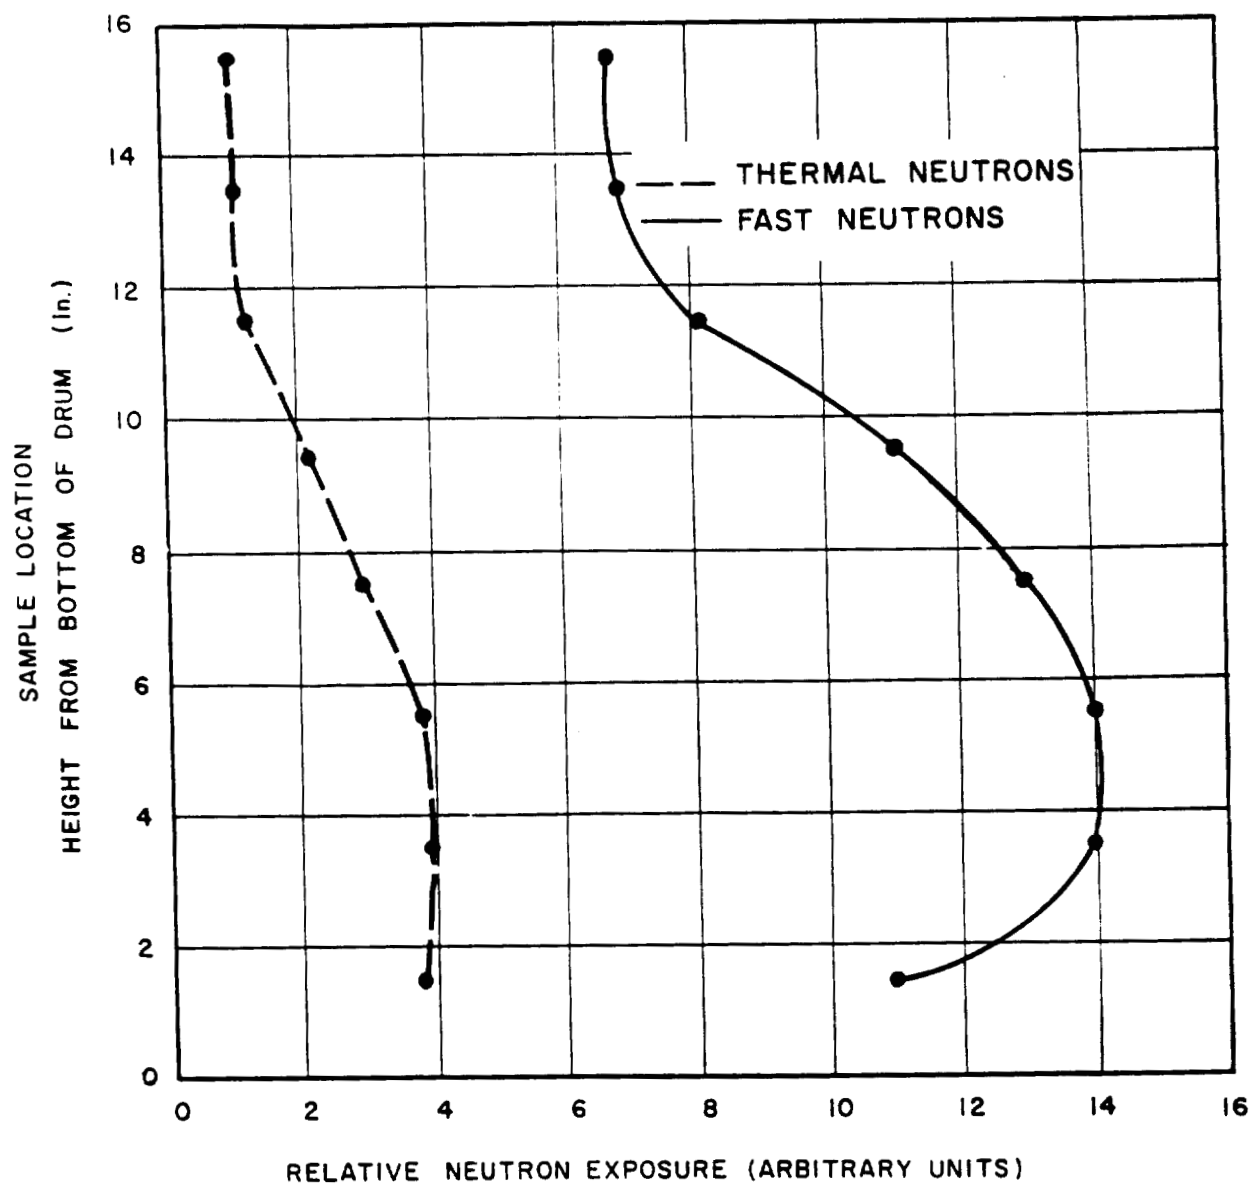
Activity was induced by neutrons in the components of the stainless steel of which the drum was constructed. Analyses of these activities yield at least relative values of the neutron exposure and, hence, of the neutron flux at various elevations along the side of the drum. The fast neutron measure was derived from the activity of  $\text{Co}^{58}$  arising in the  $\text{Ni}^{58}(n,p)\text{Co}^{58}$  reaction assuming an 80 mb cross section. The thermal neutrons were evaluated from the  $\text{Cr}^{51}$  activity from the  $\text{Cr}^{50}(n,\gamma)\text{Cr}^{51}$  reaction with a cross section of 15 barns. The steel analyzed 17.99 and 11.84 wt% chromium and nickel, respectively. The data are recorded in Table III and are plotted in Figure 19. The results from additional samples from peripheral locations at three elevations showed no significant asymmetry in the flux pattern in horizontal planes. It is interesting to note that the maximum activation occurred between 3 and 5 inches from

Figure 19  
ACTIVITY OF STAINLESS STEEL SAMPLES FROM Y-12 DRUM

Radioisotopic analyses were made of the stainless steel from various locations on the drum, yielding the relative neutron exposures recorded in Table III and Figure 19.

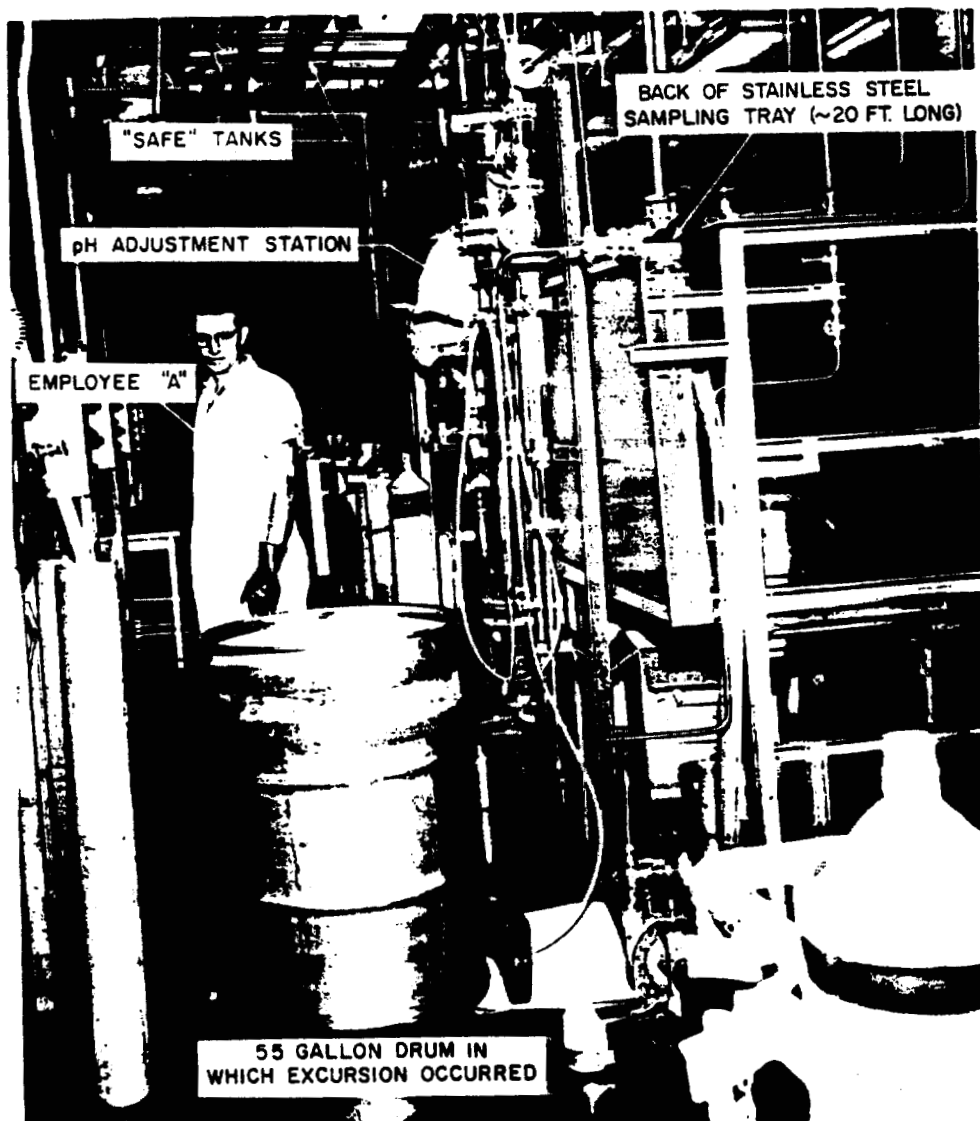
Figure M.1

POSITION OF EMPLOYEE "A" AT THE TIME OF THE INCIDENT  
Note: The high back of the sampling tray prevents Employee "A" from observing the actions of Employees "B", "C", "D", and "E". (See Figure 5)

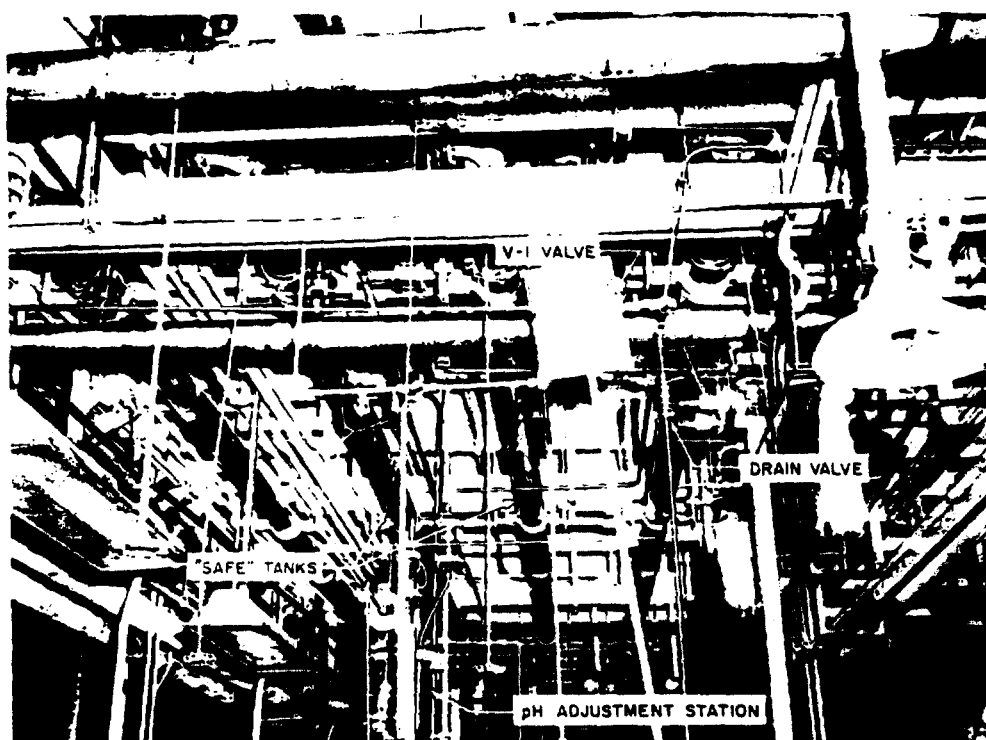
Figure M.4  
LOCATION OF V-1 VALVE AND THE DRAIN VALVE IN C-1 WING

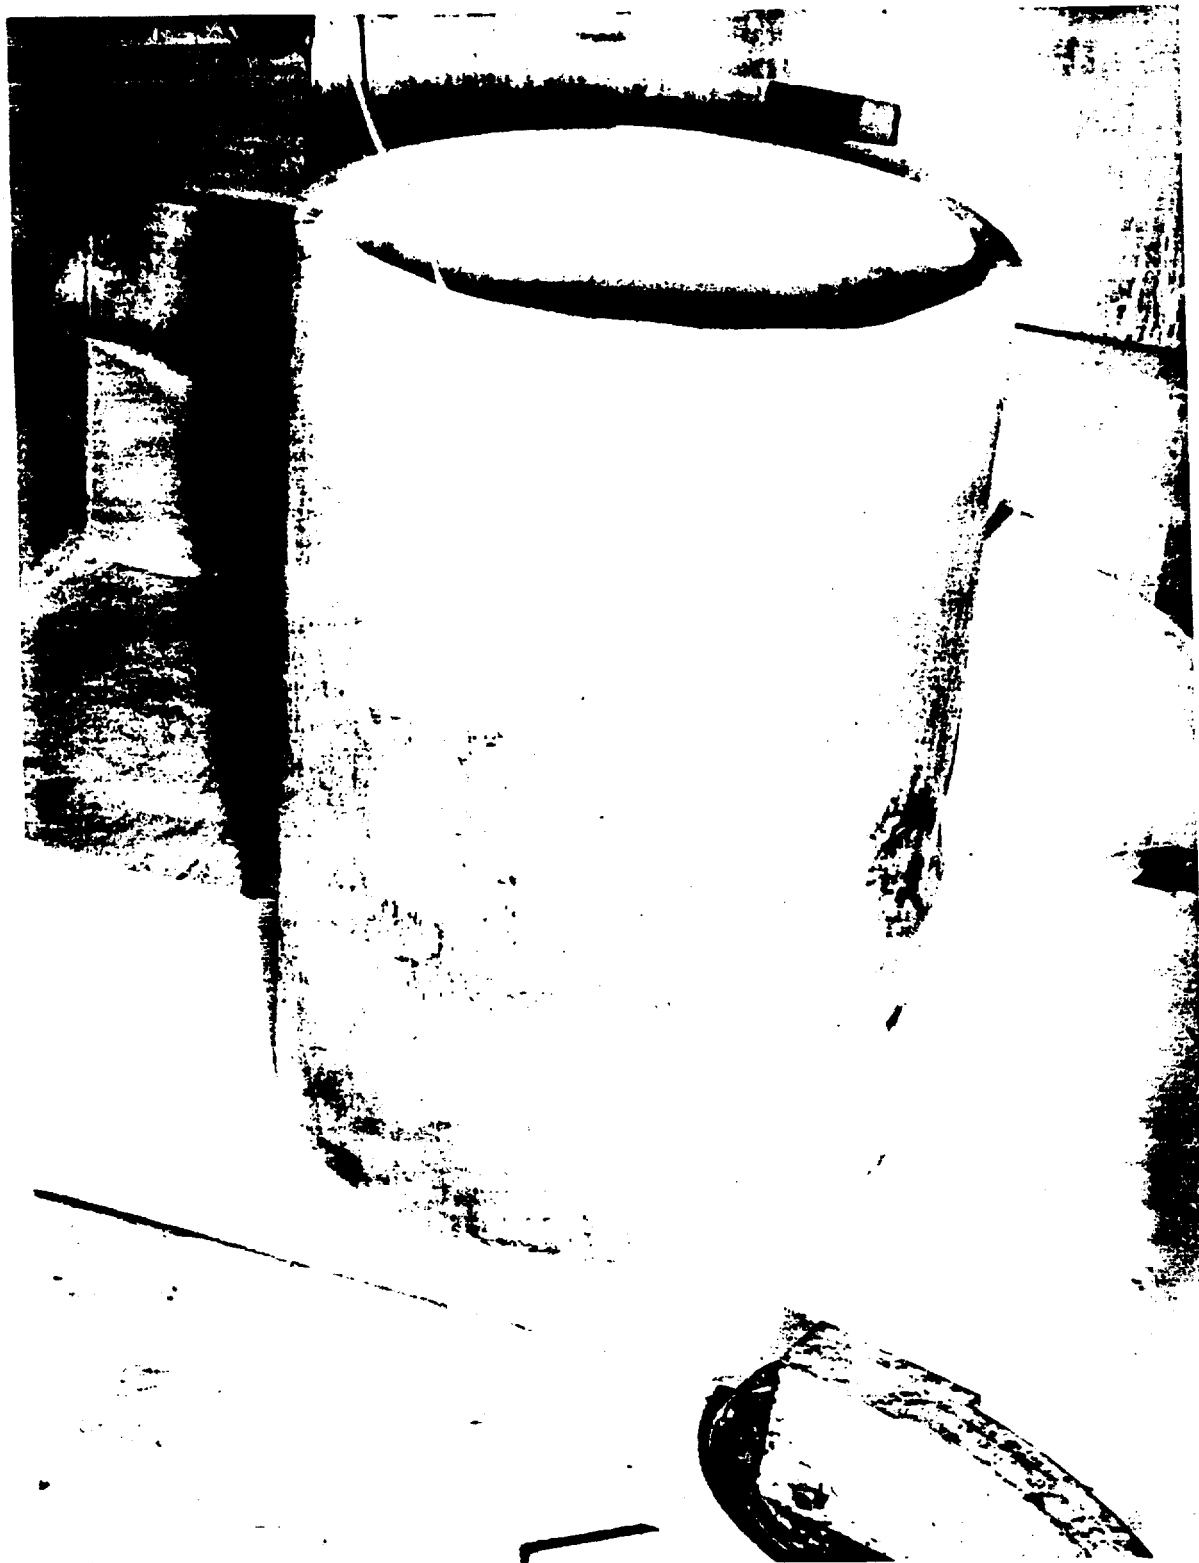
Figure M.7  
OUTSIDE SURFACE OF POLYETHYLENE LINER
